# Manhole Inspection Summary

Manhole # S41AA\_023MH

Insp Date: **1/30/09 12:19 PM**

**Location** Address: **1300 e monument st**

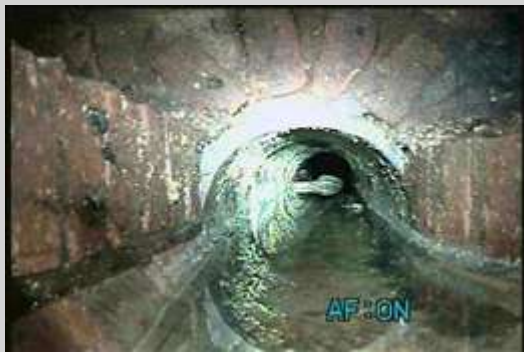
12 O'Clock Outflow

8 in. Circular Gravity Sewer  
Pipe Out @ 12 O'Clock

Pipe Material: **Clay** ☐ Pipe Lined

Invert Depth: 11.58 (ft.) Flow Characteristics: **Slow**

Infiltration: **None** Pipe Seal Cond: **Unknown**

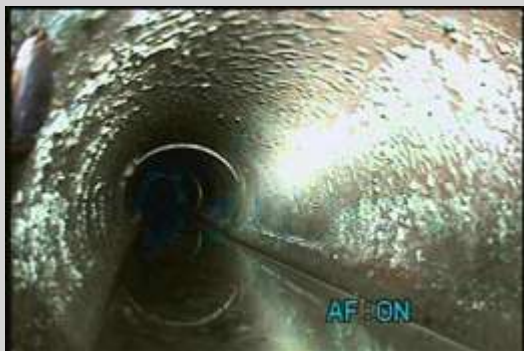
3 O'Clock Inflow

8 in. Circular Gravity Sewer  
Pipe In @ 3 O'Clock

Pipe Material: **Clay** ☐ Pipe Lined

Invert Depth: 11.41 (ft.) Flow Characteristics: **Slow**

Infiltration: **None** Pipe Seal Cond: **Unknown**

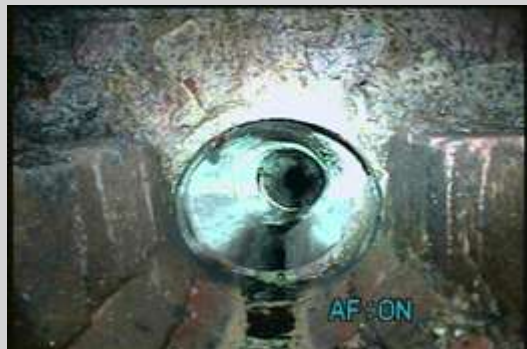
6 O'Clock Inflow

8 in. Circular Gravity Sewer  
Pipe In @ 6 O'Clock

Pipe Material: **Clay** ☐ Pipe Lined

Infiltration: **None** Pipe Seal Cond: **Unknown**
